# Crawford Station MGP Site Chicago, Illinois

# **Weekly Field Progress Report**

Report Date: July 13, 2012

The following summarizes the environmental field activities performed by NRT on behalf of IBS at the former Crawford Station MGP site Time Critical Removal Action (AOC V-W-11-C-981):

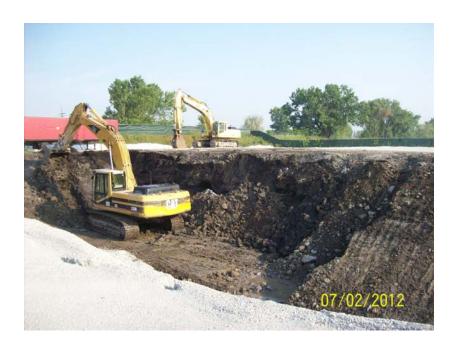
Date: July 2, 2012

Description: Looking northwest from Area A, where excavation is extended west and north of the northern extent of potential removal area due to analytical data that did not pass.

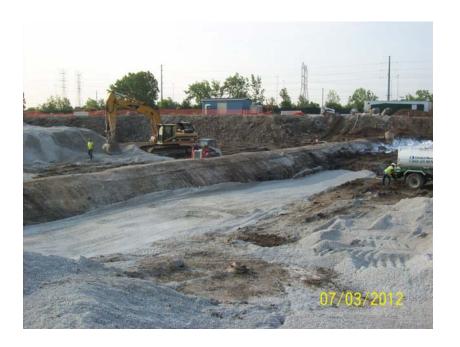
Date: July 3, 2012

Description: Tecnica backfilling on both sides of the sewer at the same time, as required by City of Chicago Water Department. View toward the southeast.

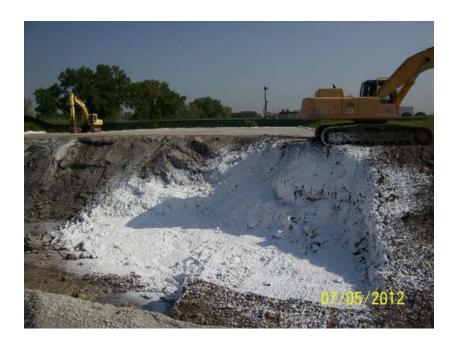
Date: July 5, 2012

Description: View from Area A looking north. Tecnica actively controlled odors through the use of wood chips and foaming, as soil is being loaded out for disposal.

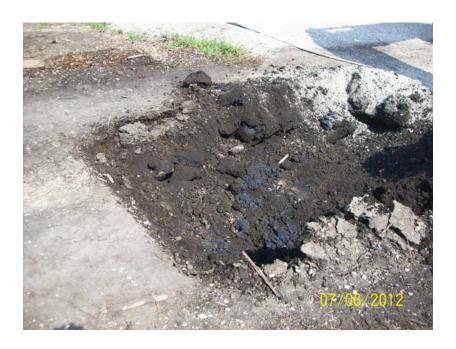
Date: July 6, 2012

Description: Looking down, black MGP impacted material onefoot below ground surface during test pit in southwestern boundary of overburden stockpile pad.
